REPORT NO. RD-64-27

FINAL REPORT  
Project No. 432-1-5V

EVALUATION OF LIGHTED  
CROSSBARS AND LIGHTED  
RUNWAY DISTANCE MARKERS

FEDERAL AVIATION AGENCY  
Systems Research & Development Service  
EVALUATION DIVISION  
Atlantic City, New Jersey

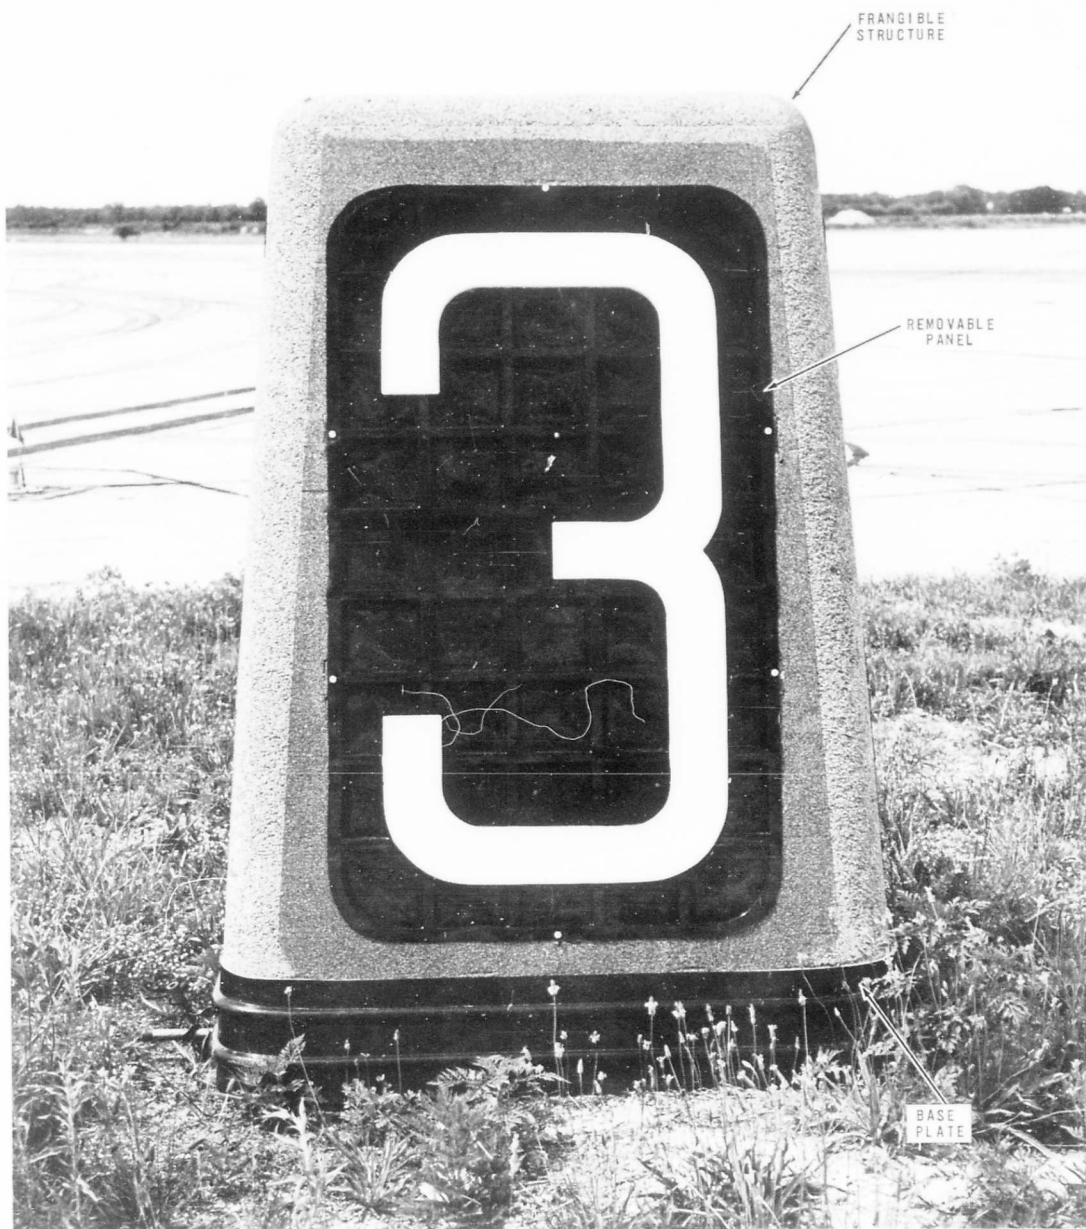
FIG. 5 RUNWAY DISTANCE MARKER

**Lighted Distance Markers:** The lighted runway distance markers manufactured by Aeronautical Incorporated (FIG. 5) were of a triangular shape, six feet high and mounted on a four-foot square base. These markers were assembled from three components: (1) a frangible structure, (2) a removable numeral panel, (3) a base plate with lamps for internal lighting.

The frangible structure was of steam molded Dylite Polystyrene beads,  $\frac{1}{8}$  inch to  $\frac{3}{16}$  inch in size. The density of the Dylite material was approximately one pound per cubic foot, the compressive strength was 12-22 psi, and the tensile strength 25-55 psi.

Numeral panels were made of acetate butyrate 0.060 inches thick and approximately three feet wide and five feet high. Each numeral was two feet wide by four feet high, translucent white against an opaque black background. The panel was secured to the frangible basic structure by six plastic nuts and bolts. Each marker contained two numeral panels, mounted back to back, to permit viewing from either side.

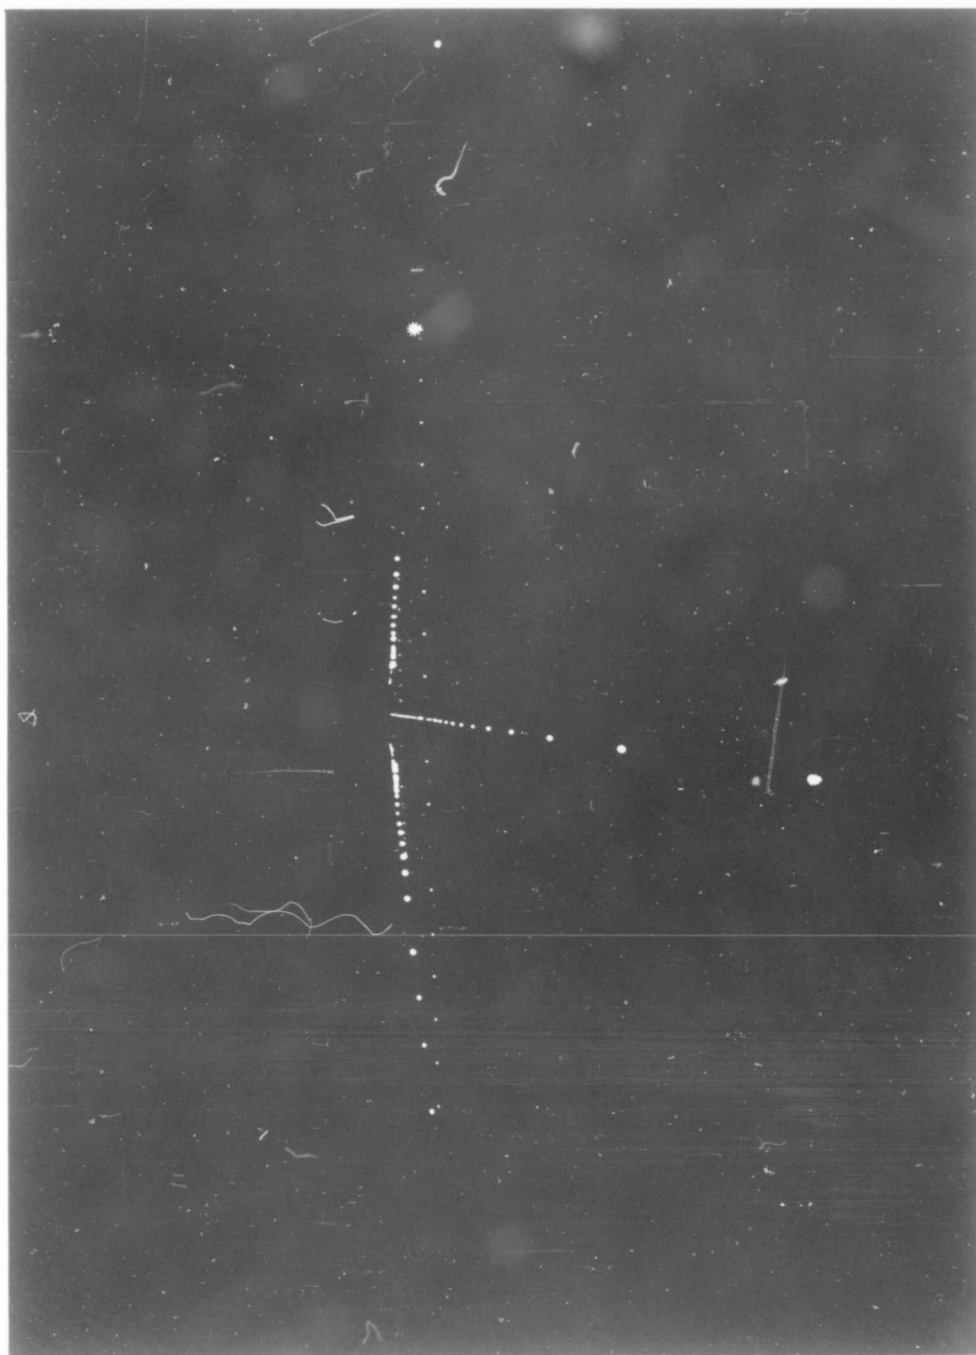
FIG. 9 PATTERN "A" - CROSSBARS WITH RUNWAY EDGE AND  
CENTERLINE LIGHTING

Pattern A (FIG. 9) consisted of the crossbars plus runway edge and centerline lighting.

Phase I - With Pattern A, the lighted crossbars offered the only means of position identification. This pattern made it necessary for the pilot to note each crossbar in passing and mentally subtract the rows from the total runway length or use a countdown technique to determine the distance-to-go. In checking takeoff performance, pilots simply counted the crossbars to determine the distance traveled. In this pattern a mistake in counting could not be corrected.

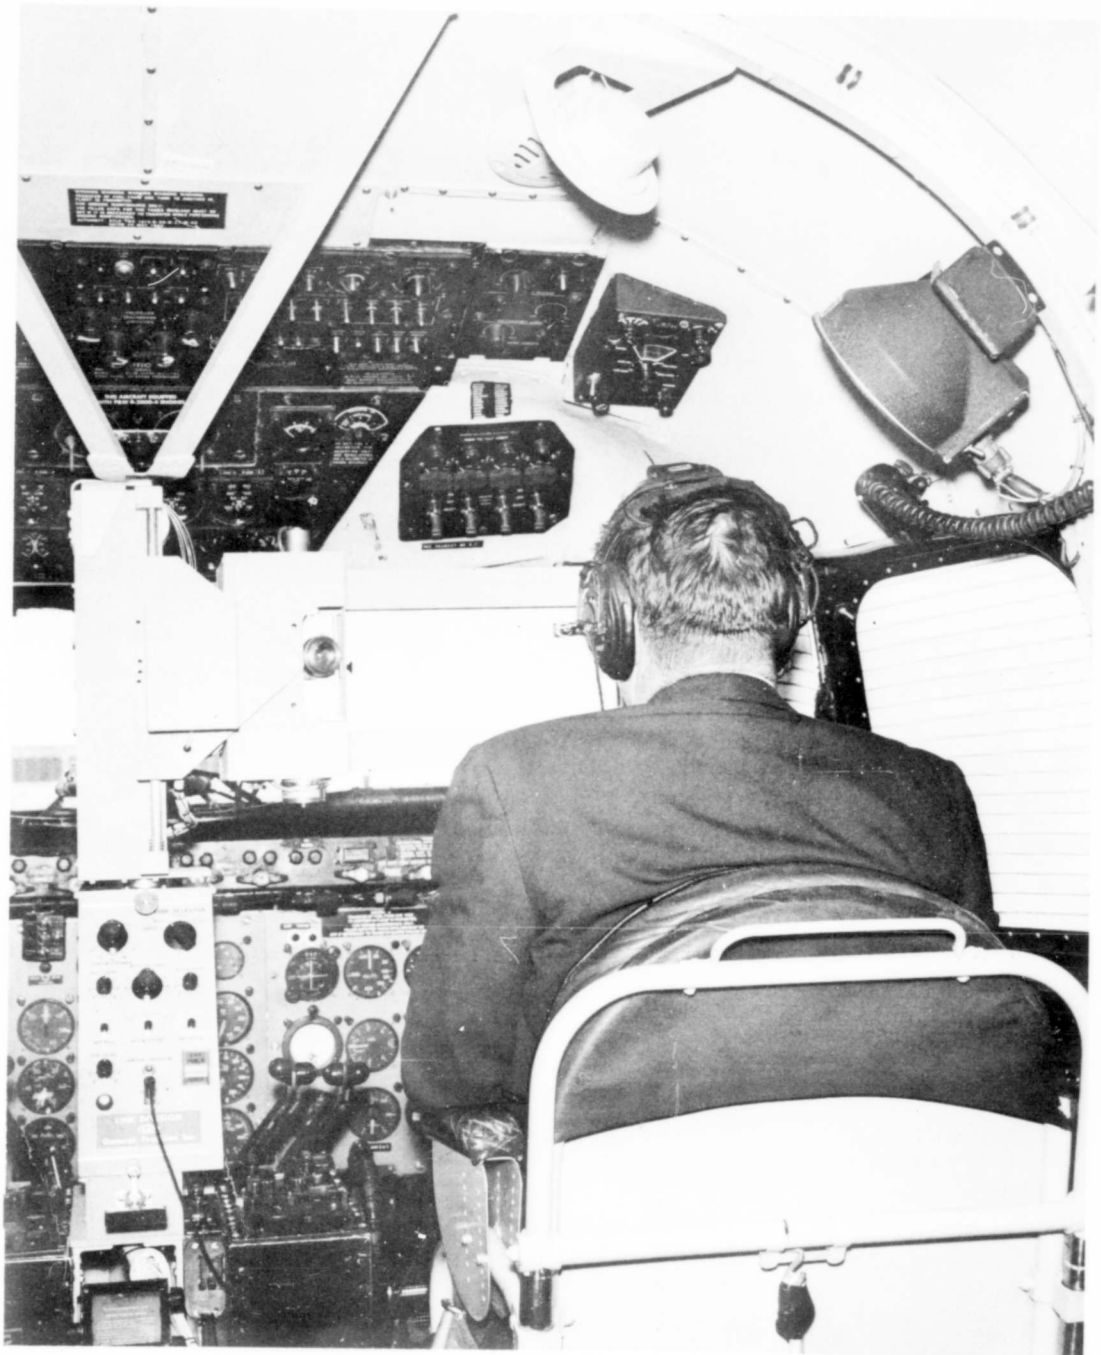
FIG. 12 LINK DIVISION FOG SIMULATOR INSTALLED IN C-54G  
COCKPIT

An effort was made to maintain controlled visibility conditions during Phase II, using the Link Division Airborne Fog Simulator (FIG. 12) and fixed sheets of Mylar film. The Fog Simulator and the Mylar film were developed to simulate day and night fog conditions during landing and takeoff maneuvers. Each visibility range was simulated by an 8-inch wide Mylar film sprayed with clear lacquer to obtain fog impressions (similar to a steamed-up windshield in a car).<sup>1</sup> A runway visual range of 1500 feet was simulated during the flight test program.

Pilot observations and comments concerning the accuracy of the simulation procedure indicated that they felt the use of Mylar film resulted in reasonably accurate RVR simulated conditions. However, they also noted the following discrepancies between the simulated and actual fog conditions:

1. White lights viewed through the Mylar film tended to appear reddish-orange.
2. An intense halo of diffused light surrounded the light source, especially when viewed at close ranges.
